Re: 200 New Street
Newtown, New York

Building Analysis Report

For
200 New Street, Newtown, New York
October 6, 2021

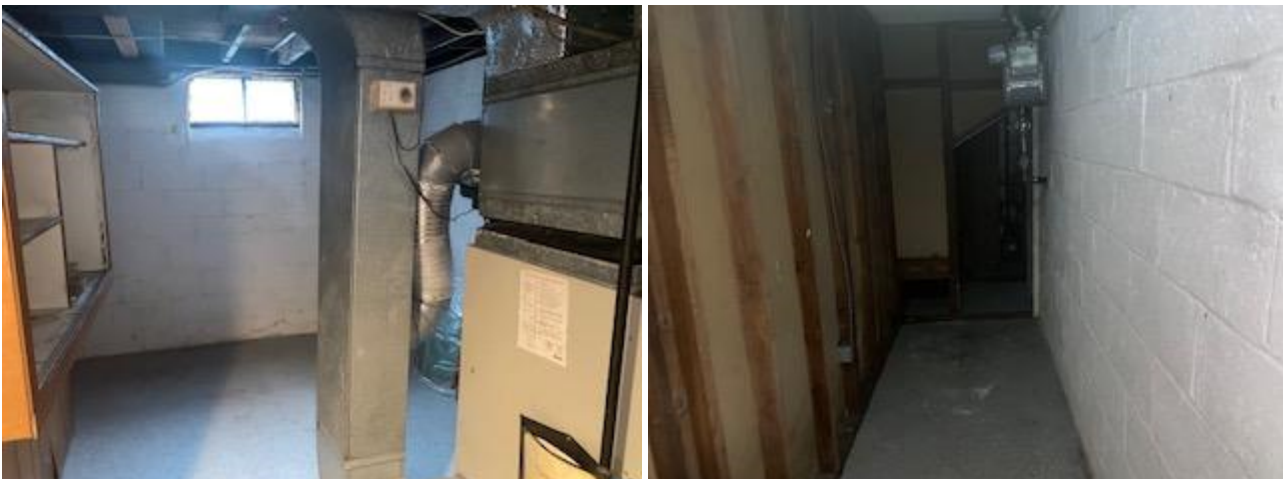
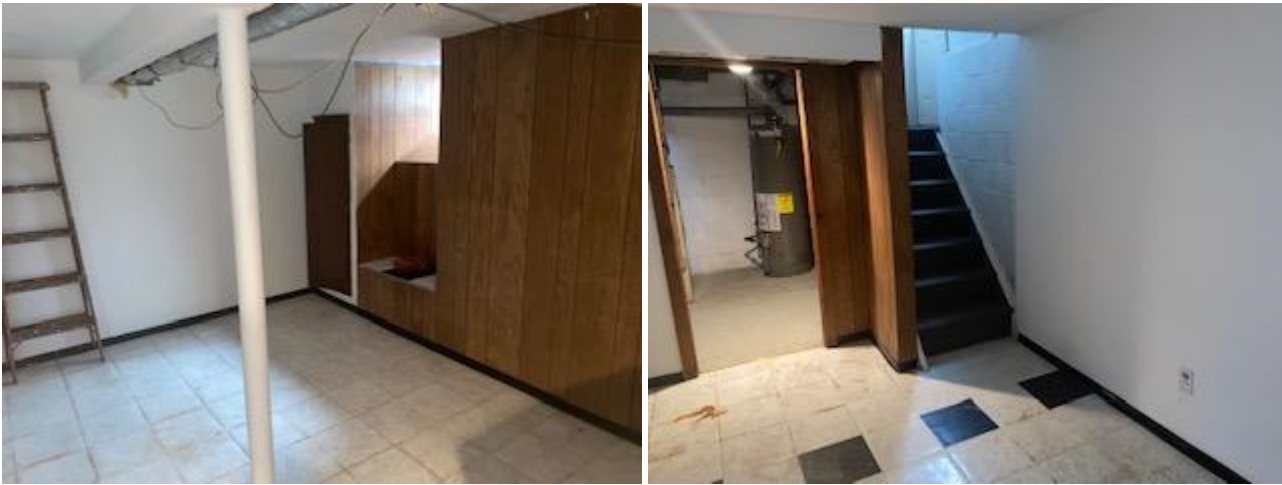
The floor covering is resilient tile. It is loose and these areas should be properly secured or replaced.

Walls: The walls are concrete block and covered with drywall or paneling or wood. They are in acceptable condition. **The wall coverings are damaged and have mold present and should be removed and all areas professionally cleaned/sanitized.**

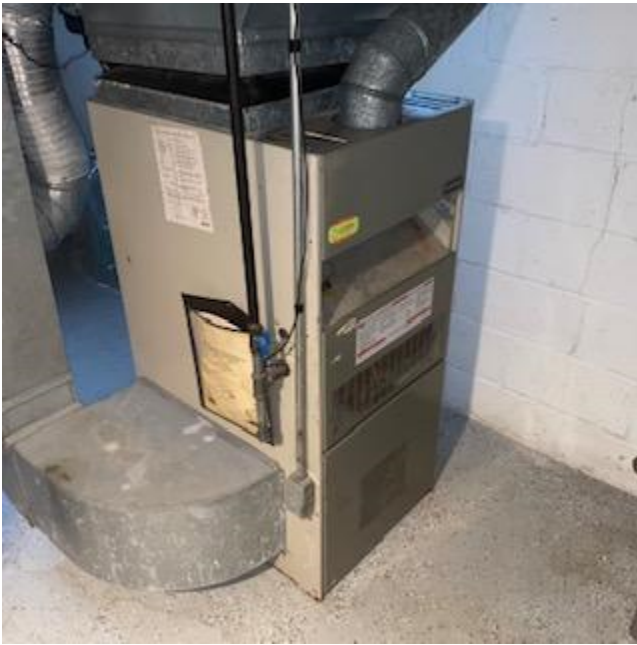
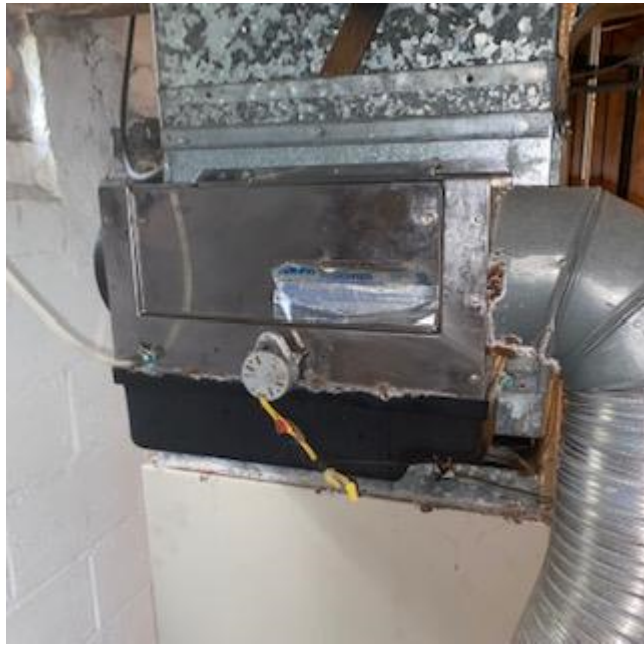
The unit it is functioning properly but **should be replaced due to its age.** The humidifier is leaking and missing parts.

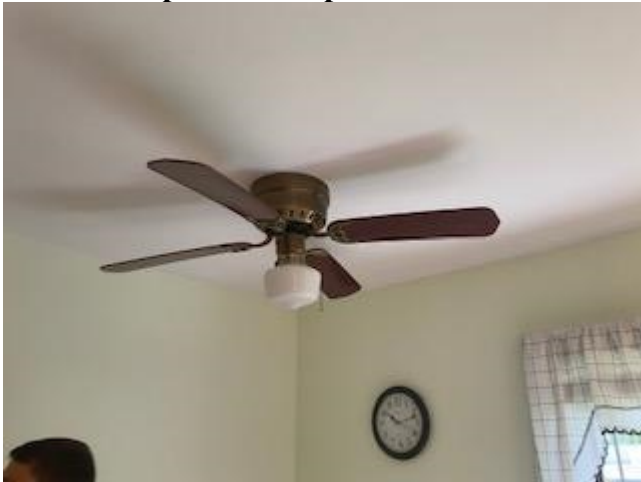
Cooling: Type: Ceiling Fan
should be repaired or replaced.

The ceiling fan in the Kitchen has a **light unit that is not functional and**

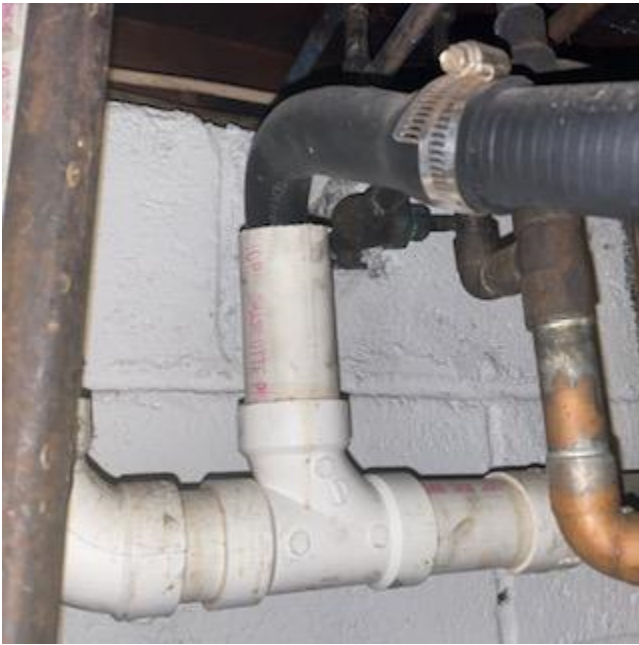
The waste lines inside the home are plastic and cast iron. They are in acceptable condition **but have some open waste lines which should be repaired/capped.** Some sections are unable to be visually inspected as they are contained within the structure of the home.

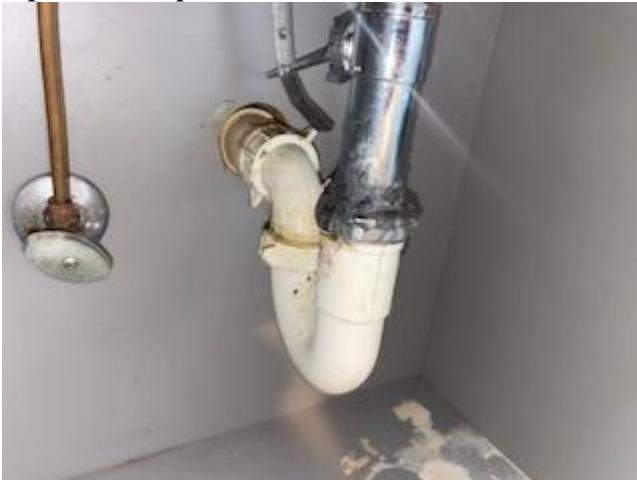
The sink is in acceptable condition and functioning properly but **the trap is rusted/corroded/improper and should be repaired or replaced.**

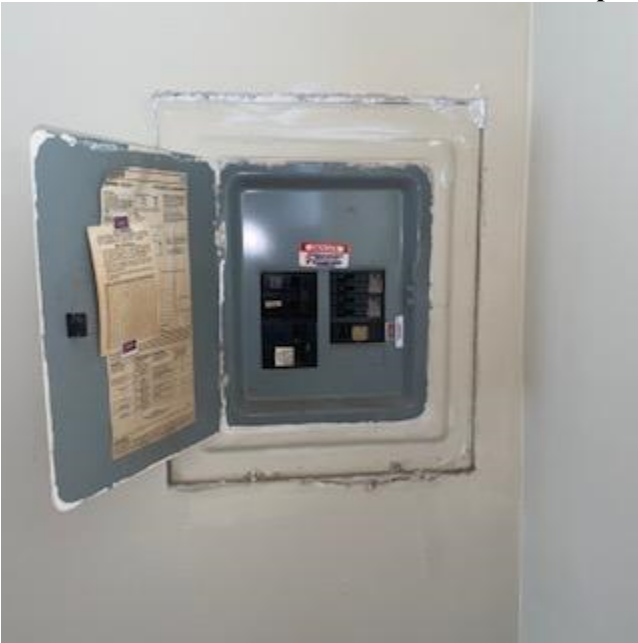
Panel Box: The panel box has a capacity of 100 amps and is located in the Den. The box could not be fully inspected as the cover could not be removed **and should be inspected prior to closing.**

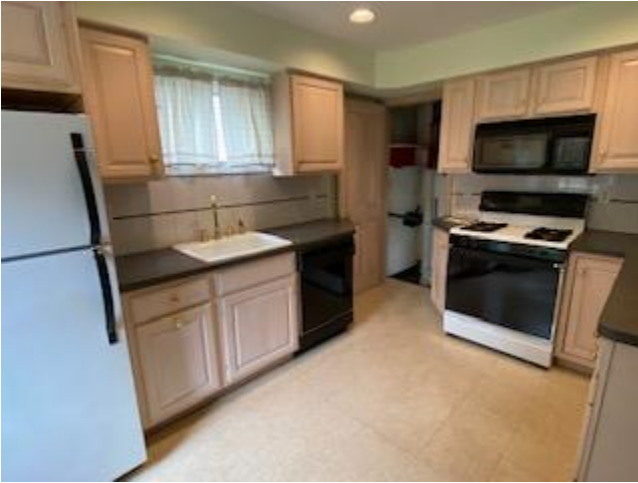
Cabinets: The wood cabinets are in acceptable condition but **improperly secured to the wall and should be properly secured.**

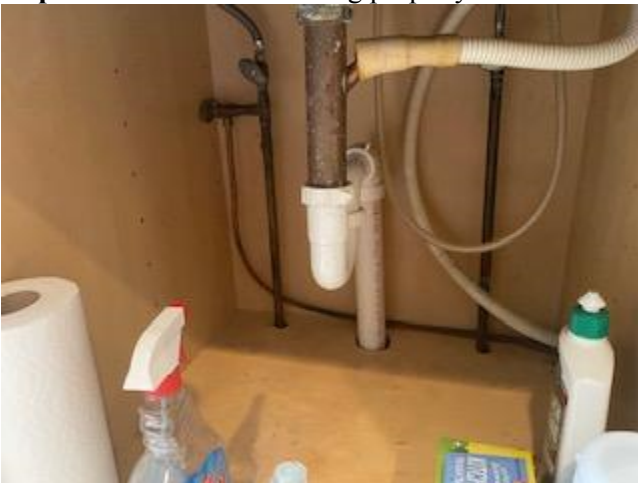
Sink: The sink is in acceptable condition **but the trap is improper as it is an S-trap and should be replaced with a P-trap.** The faucet is functioning properly with no leaks and the sprayer is functioning properly with no leaks.

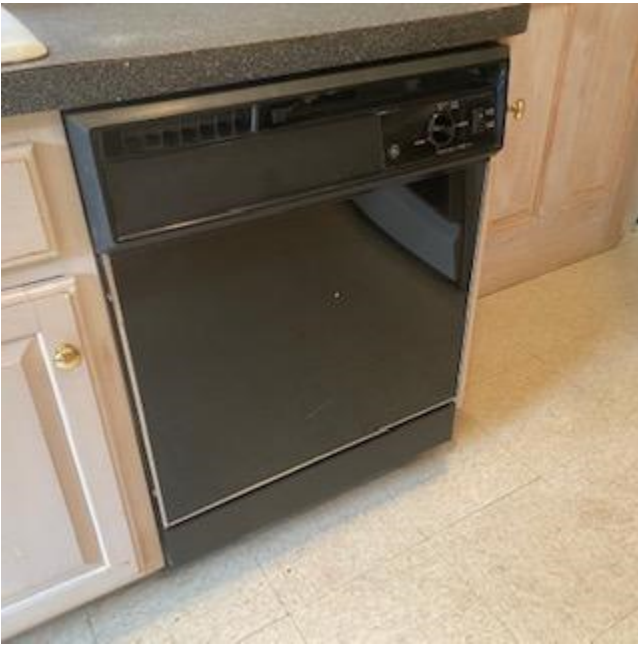
Dishwasher: Age: Older.

The dishwasher was not tested due to its age **and should be replaced.**

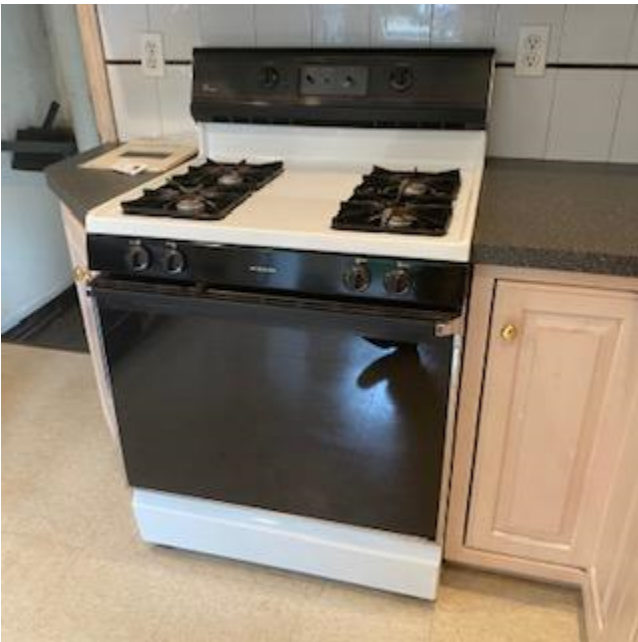
It has some burners/elements that are not functioning properly which be repaired or replaced.

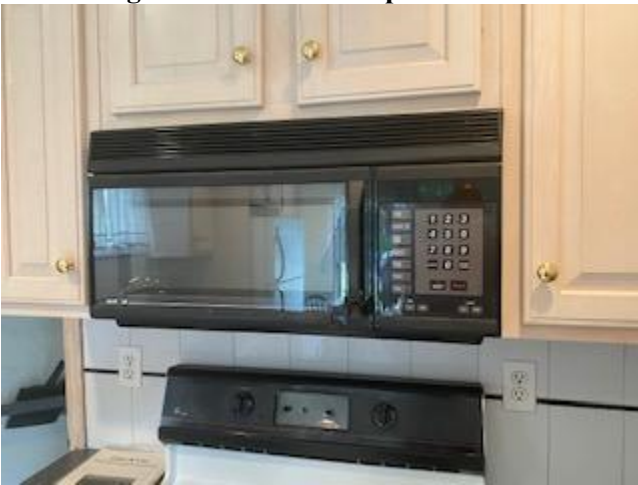
It is damaged and should be replaced.

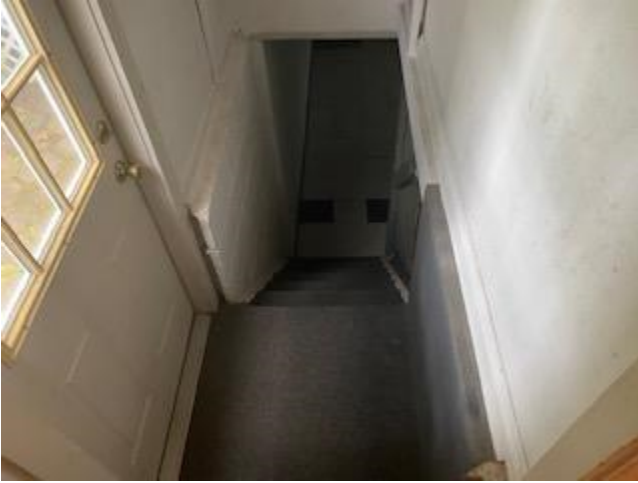
Stairs: The stairs to the basement are in acceptable condition **but need a railing along the steps.**

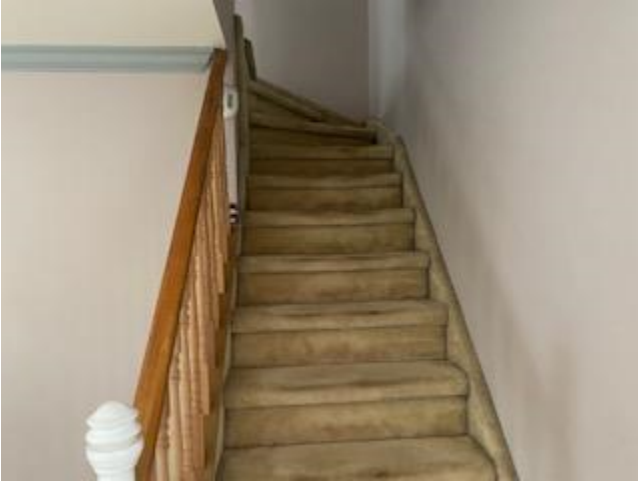
The stairs to the second floor are in acceptable condition **but need a railing along the upper steps.**

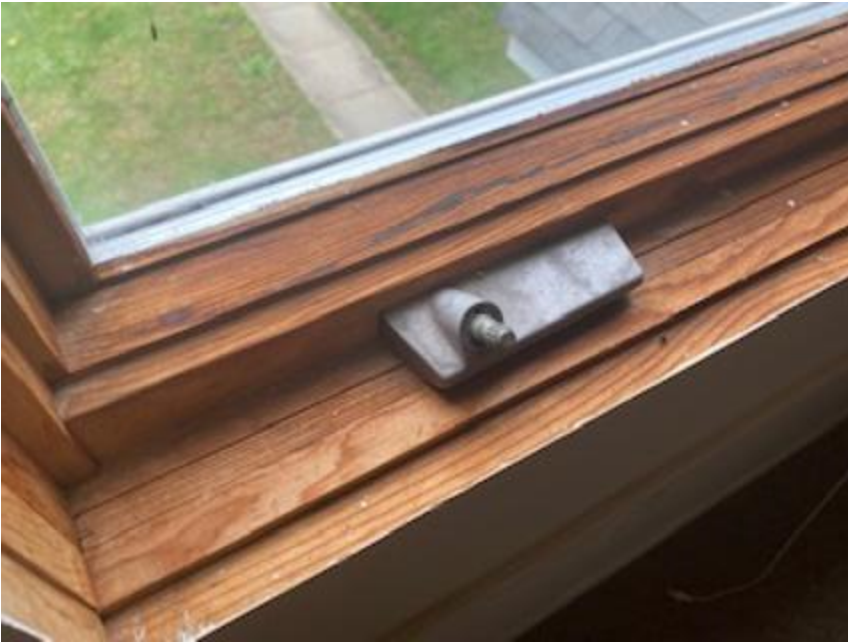
Windows: The windows have **some with cracked/broken glass which should be repaired or replaced and have some that are difficult to open and close and should be repaired or replaced and have some missing hardware which should be replaced.** They have insulated and single pane glass.

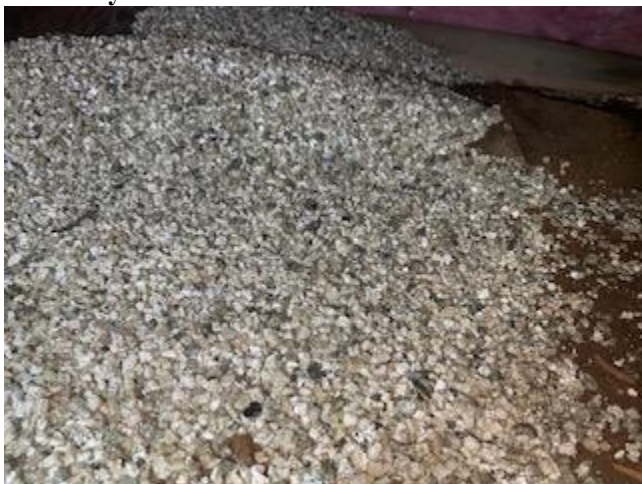
Insulation: Fiberglass insulation and Cellulose insulation and **Vermiculite, which can contain asbestos and should be tested by a licensed asbestos contractor.** It has an average thickness of 3-6 inches. The insulation is in acceptable condition. **The amount of insulation is not adequate. It is recommended additional insulation be installed for energy efficiency.**

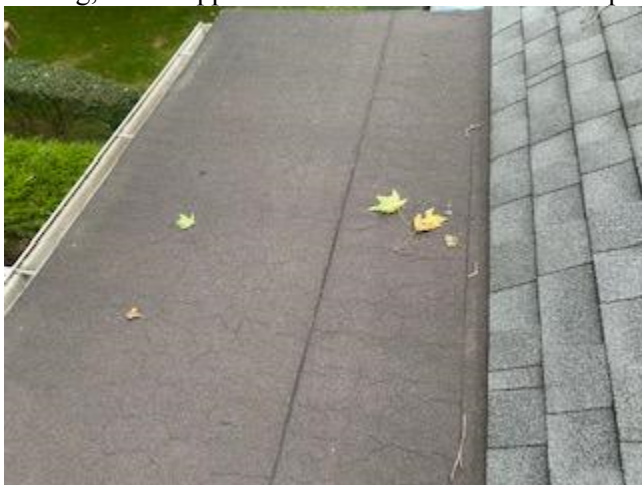
The second roof area is covered with an undetermined amount of roll roofing. The top layer is asphalt composition roll roofing, which appears to be at the end of its life expectancy with missing particulate.

The roof covering should be re-roofed.

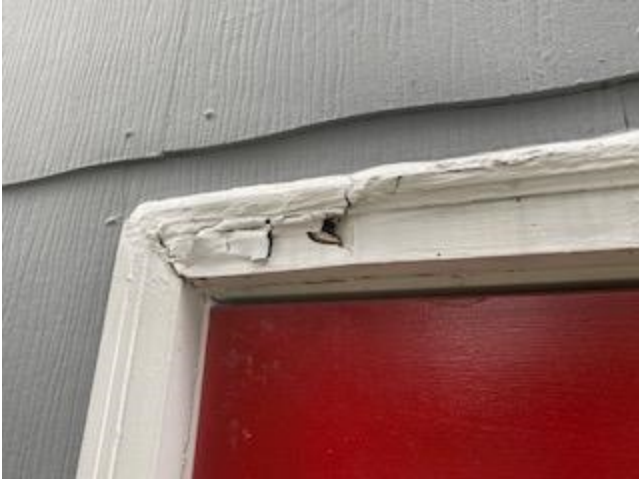
The basement entry door(s) is in acceptable condition and functioning properly, **but the trim is water damaged and should be replaced.**

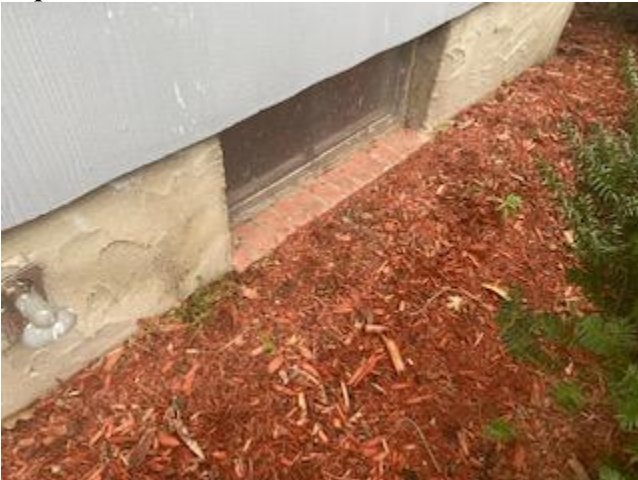
Window well(s): Window well(s) at the basement window(s) is/are **not present and should be installed where required.**

It is recommended window well(s) be installed at any basement/crawlspace windows where the soil is less than 6 to 8 inches below the window.

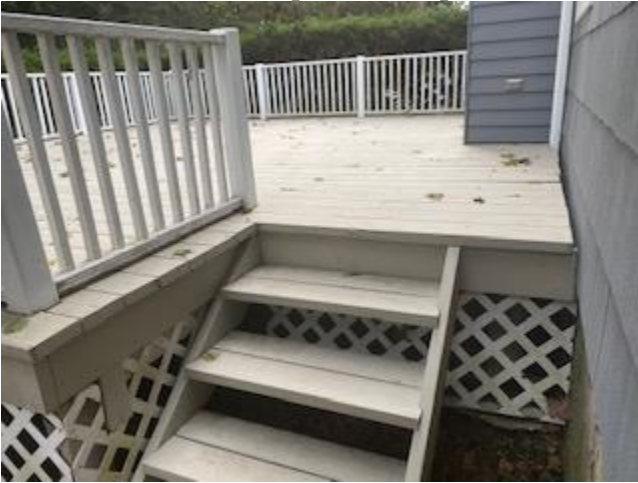
It is secure, fairly level and in acceptable condition **but needs a railing installed at the steps and the railing is installed to low and should be repaired or replaced.**

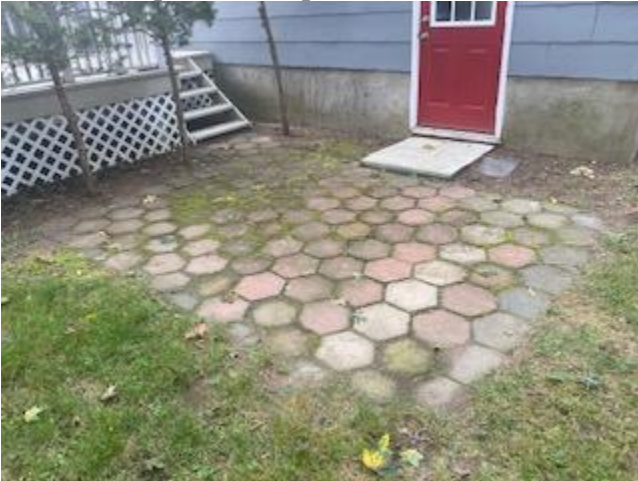
Patio/terrace: A patio is located off the rear of the home. It is constructed of concrete pavers. The patio is **uneven and should be repaired or replaced.**

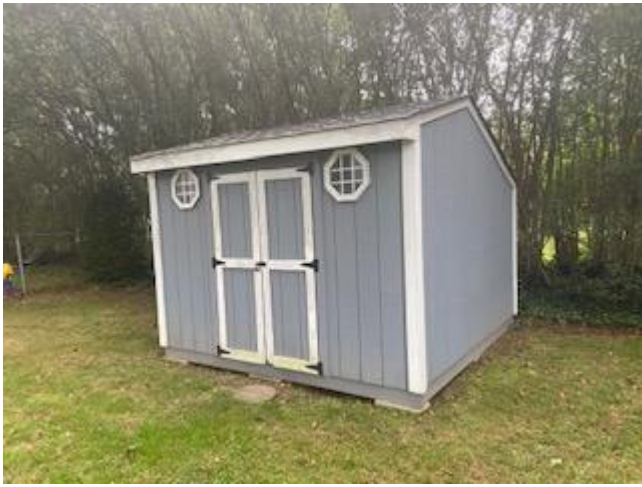
Outbuildings: The outbuilding at the back yard is in acceptable condition but is sitting too close to the property line and is improperly framed and should be repaired or replaced and locked and therefore the interior could not be inspected.
