Home Sweet Home Inspections, Inc.

BUILDING ANALYSIS REPORT

10 New Street, New Town, New York

August 17, 2012

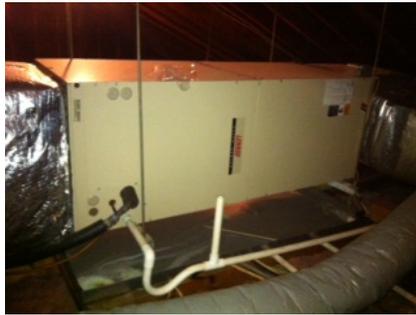
Ductwork distributes the cooled air to registers located throughout the home. The ductwork and registers appear to be in acceptable condition and functioning properly. The air handler is located in the attic. It appears to be in acceptable condition and functioning properly. A drip pan is present.

The disposable filter appears to be in poor condition and dirty. **It is recommended the filter be replaced.** The system was tested on a random setting and temperature. It appears to be in fair condition with low air flow. **It is recommended the system be repaired by a licensed HVAC contractor.**

3. The a/c system should be repaired by a licensed HVAC contractor.
4. The electric wires improperly running through the plumbing chase should be properly installed by a licensed electrician.

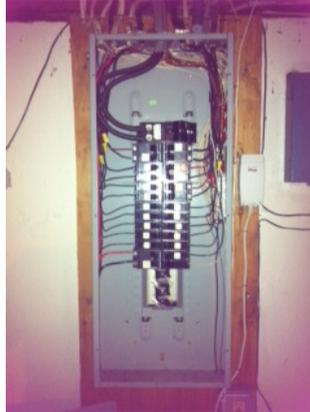
Service: Location: East side of the home Meter brand: General Electric
Line entrance: underground Cable size: 200 amps
Type 3 wire capable of supplying both 110 and 220 volts.
The service line entering the house is copper and appears to be in acceptable condition.
The panel box is a Crouse Hinds - 200 amps - with circuit breakers. The box appears to be in acceptable condition and is located in the basement.

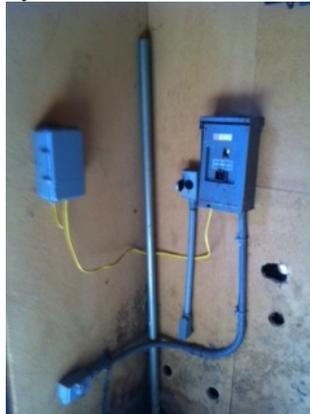
There is a sub-panel box present in the shed. It is a Federal Pacific, Stab-Lok model with circuit breakers. This model box is known for defects. The box appears to be in poor condition with rust on the interior. **It is recommended the box be replaced by a licensed electrician.** The power to the shed is off.

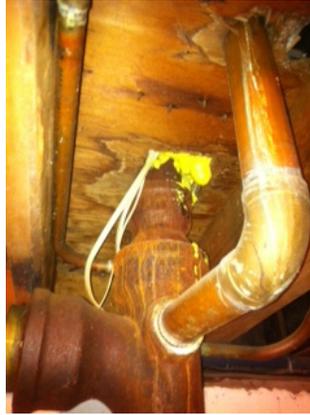
Conductors: The conductors are copper and aluminum, as viewed from the panel box.
The visible wiring is romex, which appears to be in acceptable to fair condition. Some romex wiring in the home is improperly installed through a plumbing chase. **It is recommended these wires be properly installed by a licensed electrician.**

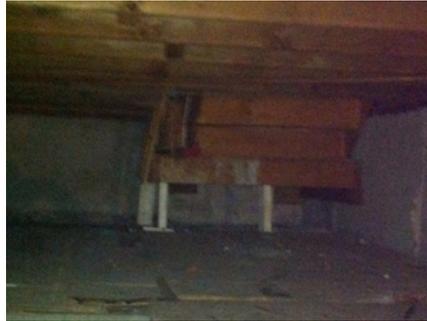
The steps to the mud room are improperly supported. **It is recommended these steps be properly supported by a licensed contractor.**

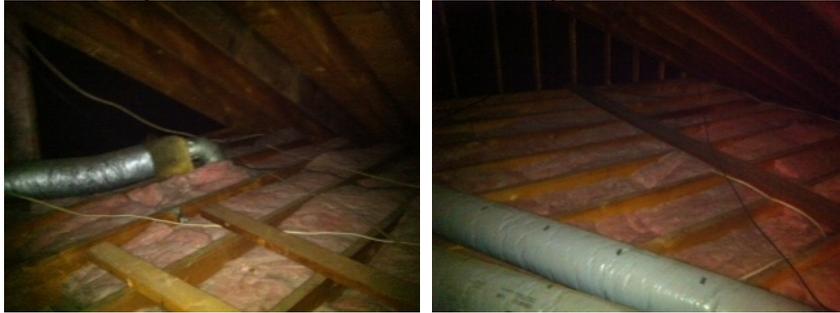
Access: The attic has access via one scuttlehole located in the garage and one in the southeast bedroom closet. Each scuttlehole requires a ladder to enter. Access is adequate in both areas.

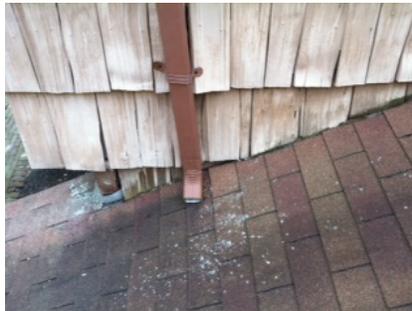
Flashing: The flashing is aluminum and copper. It appears to be in acceptable to fair condition. The flashing from the lower roof to the siding is improperly installed. **It is recommended this area be properly flashed by a licensed roofer.**

11. The windows which are stuck in the closed position should be repaired or replaced by a licensed contractor.
12. The area at the lower roof to siding interface should be properly flashed by a licensed roofer.

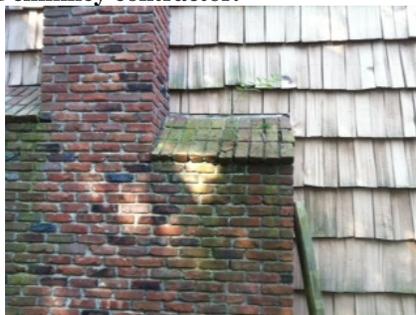
Chimney: There is a brick chimney located on the east side of the home. It appears to be in fair condition as the mid-section has loose bricks and mortar. **It is recommended the chimney be repaired/repointed by a licensed chimney contractor.**

13. The two rotted awning windows at the north side of the basement and one on the east side should be replaced by a licensed contractor.
14. The chimney should be repaired/repointed by a licensed contractor.

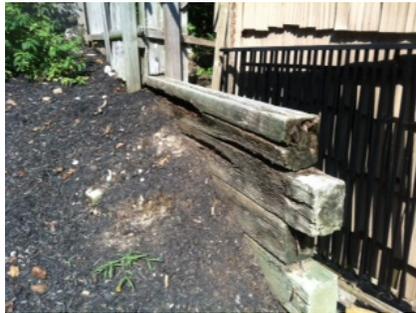
Retaining Wall: A landscape tie retaining wall is present on the west side of the back yard. It appears to be in poor condition due to age and damage. **It is recommended the wall be replaced by a licensed contractor.**

15. A licensed electrician should install a dedicated outlet for the garage door openers.
16. The retaining wall should be replaced by a licensed contractor.

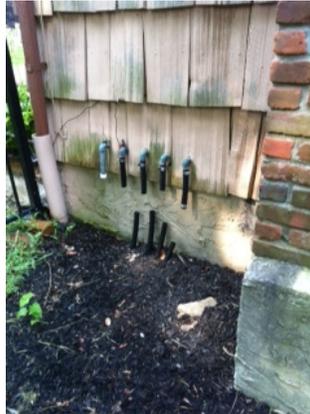
Underground Sprinklers: The system is not covered by this inspection. The sprinkler pipes are severed on the exterior. **It is recommended the 11 old sprinkler pipes (3/4 inch copper) on the east side going through the wall be removed and the holes in the wall be sealed by a licensed contractor.**
