Re: 200 New Street
Newtown, New York

Building Analysis Report

For
200 New Street, Newtown, New York
October 6, 2021

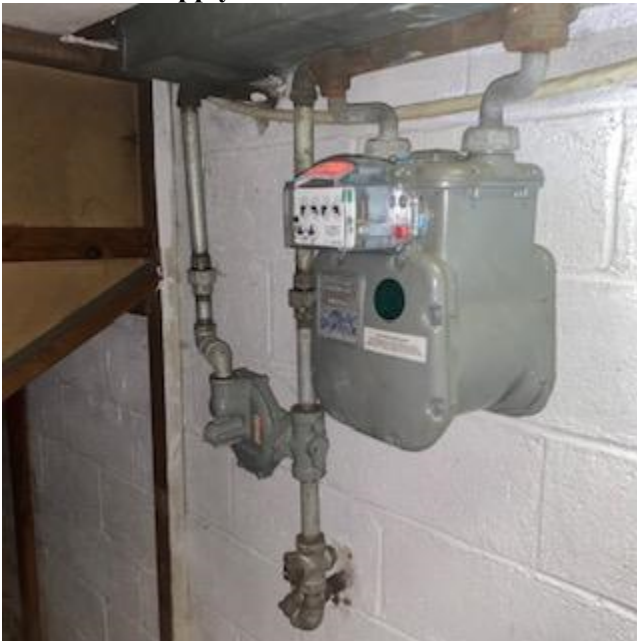
Public Gas Supply: There are no leaks are detected. The shut-off is located in the basement.

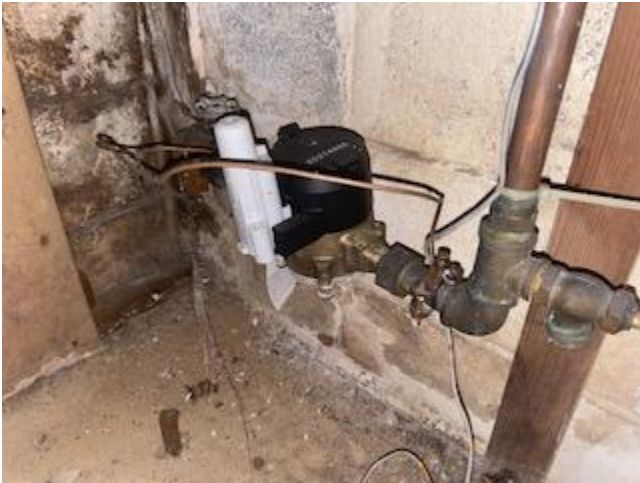
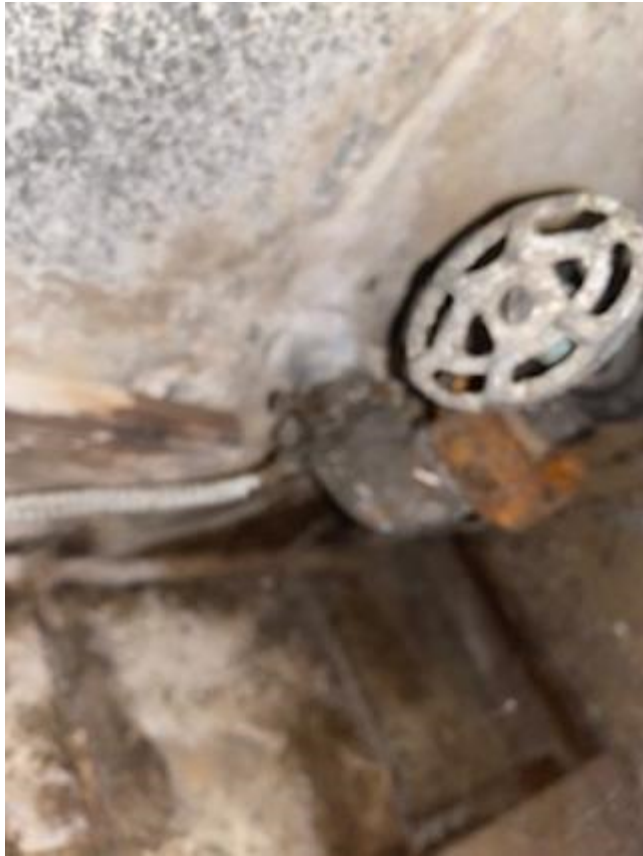
Interior Supply Pipes: The visible portions of the piping for the branch lines are copper but the main to the street is galvanized metal. If there are galvanized pipes, these tend to build up material on the interior as they age, reducing flow rate and rotting from the inside. It is recommended you budget to replace these pipes in the near future.

There is a 3/4 inch diameter house main, which connects to 1/2 inch distribution pipes.

The visible interior pipes are in acceptable condition with no leaks or signs of leaks detected.

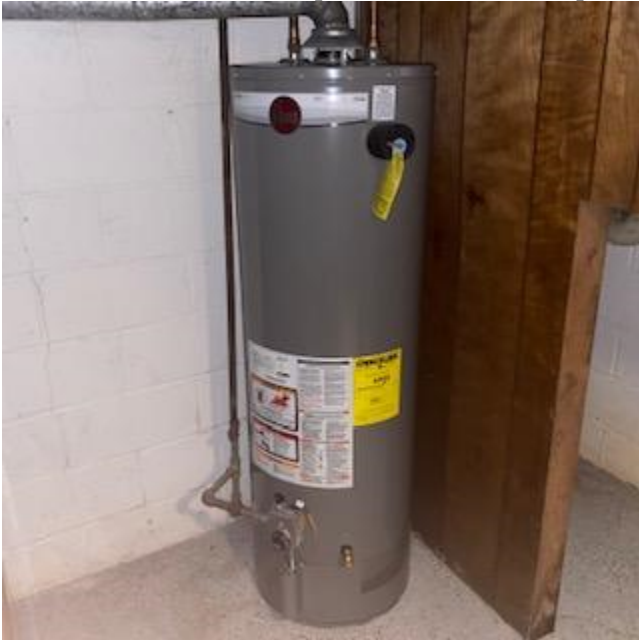
The water heater is in acceptable condition and operating properly.

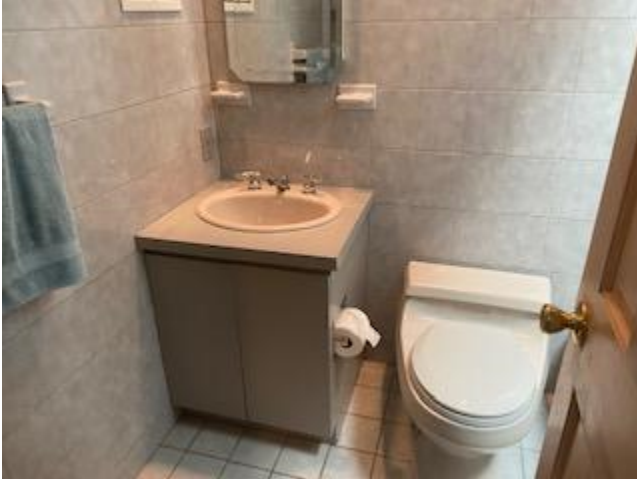
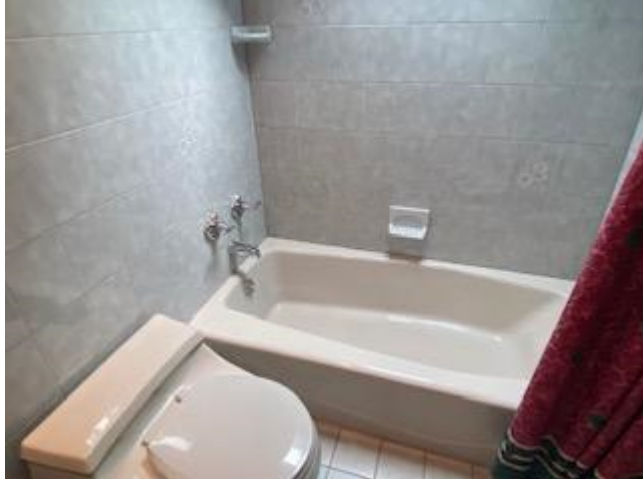
It contains a toilet and tub and single sink.

The sink is in acceptable condition and functioning properly but **the trap is rusted/corroded/improper and should be repaired or replaced.**

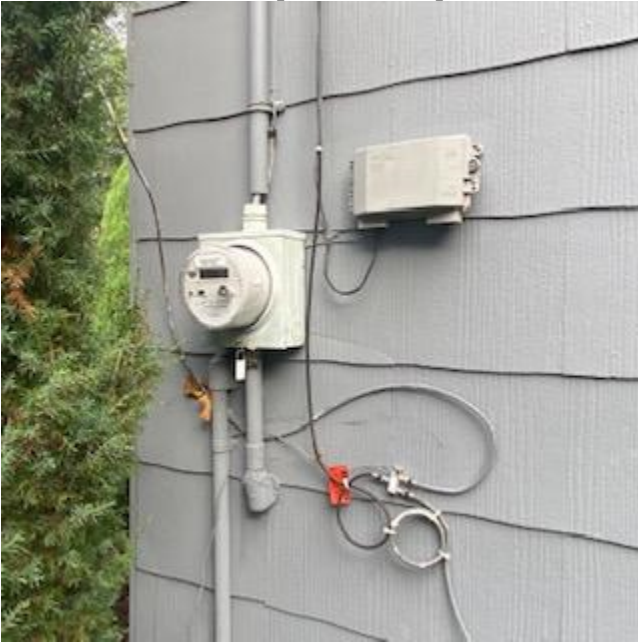
Meter Pan: The meter pan is in acceptable condition.

Service line: The electric service line entering the house is a type 3 wire capable of supplying both 110 and 220 volts. It is in acceptable condition.

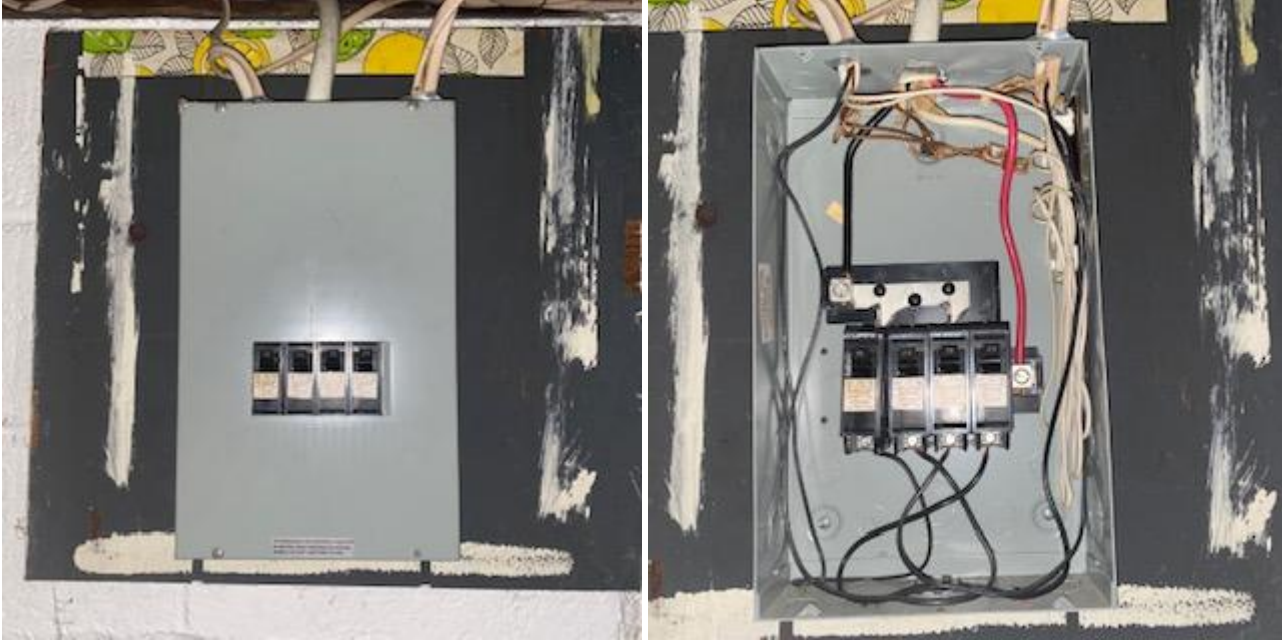
Sub-Panel Box: The sub panel box has a capacity of 50 amps. It is located in the basement. The sub-panel box is in

acceptable condition.

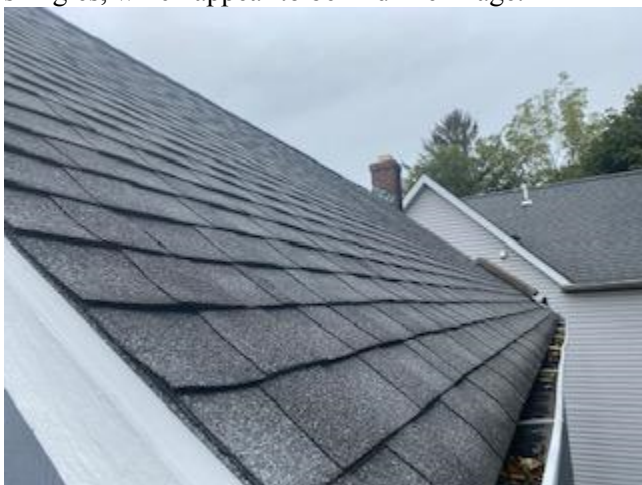
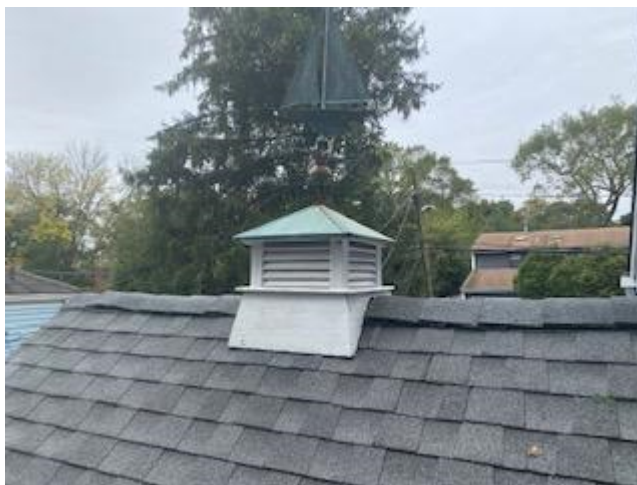
Location: The roof areas are covered with 1 layer of shingles. The top layer is architectural type, asphalt composition shingles, which appear to be mid-life in age.

The roof covering is in acceptable condition with no leaks detected. The roof has a remaining life expectancy of up to approximately ten years.

The second roof area is covered with an undetermined amount of roll roofing. The top layer is asphalt composition roll roofing, which appears to be at the end of its life expectancy with missing particulate.

7. **Roofing - Roll Roofing Condition:** The roof covering should be re-roofed.
8. **Kitchen #1 - Stove Condition:** It has some burners/elements that are not functioning properly which be repaired or replaced.

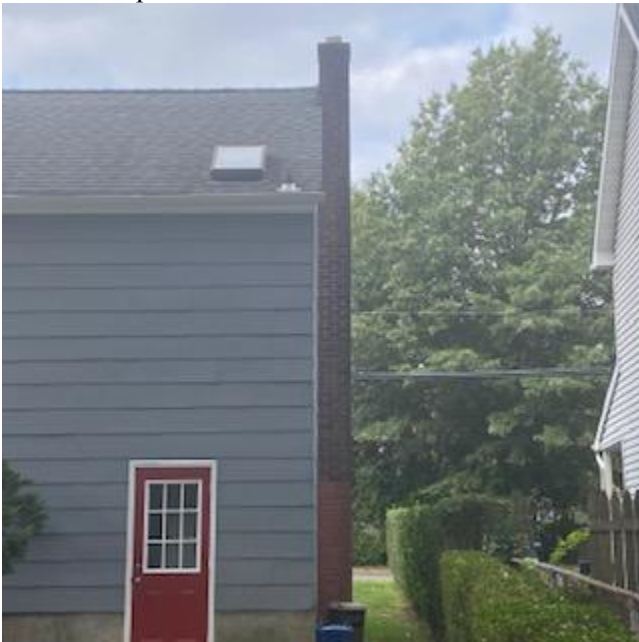
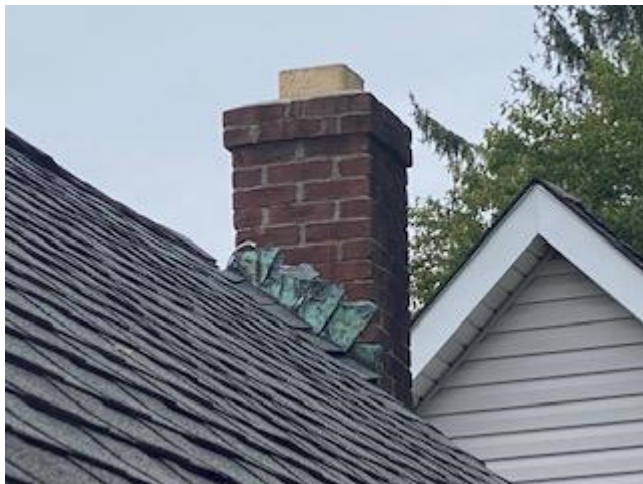
Chimney #1: There is a masonry chimney located on the north side of the home.

It is in acceptable condition.

As the full length cannot be inspected, you may wish to have it further evaluated by a licensed chimney contractor.

It is recommended caps be present on chimney flues to help prevent possible water and animal entry.

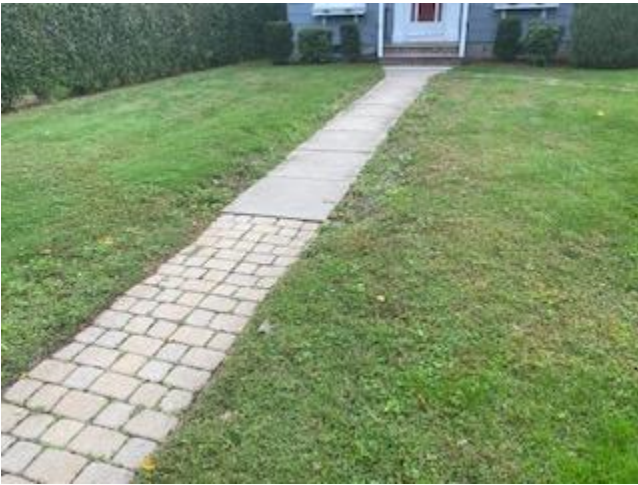
Walkways: There is/are concrete and concrete pavers walkway(s). The walkway(s) is/are fairly level and in acceptable condition.

Driveway: The driveway is gravel filled. It is fairly level and in acceptable condition but needs more stones/gravel added.
